Test Report MCS 23.09.01-part 3

Bending fatigue test of R-UHPFRC – RC composite beams

Tohru Makita
Professor Eugen Brühwiler

Lausanne, February 2014

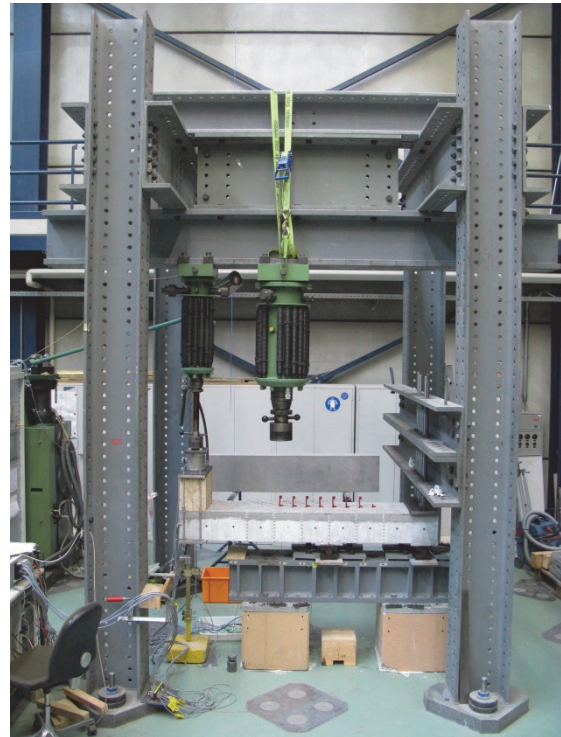
Figure 4 Test set-up

Cantilever was used as static system, representing a strip of RC bridge deck cantilever improved with R-UHPFRC (circled part in Fig. 3). Fig. 4 shows the test rigs and steel frame for the test set-up with an RU-RC beam placed with its R-UHPFRC layer of the top. Cyclic force was imposed at the end of the specimen by the hydraulic jack in force control and negative bending moment was caused on the specimen, where the R-UHPFRC layer was subjected to tension. Sinusoidal cyclic force was controlled by Amsler hydraulic actuator. Since the Amsler hydraulic actuator didn't monitor force level, a load cell installed between the jack and the specimen was used for monitoring the force level.

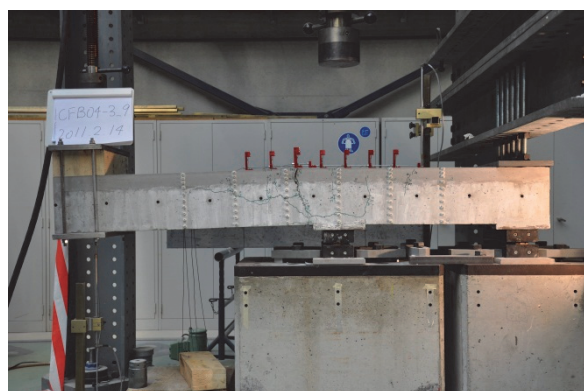
(a)

Deformation over the entire depth of the specimen:

Deformation over the entire depth of the specimen was unchanged until 500,842 cycles. On measurements at 1,001,056 cycles, deformation of tension side solely increased, amounting to 1 ‰ strain at top of R-UHPFRC layer.
